REPORT OF FATAL COAL BUMP ACCIDENT  
FEDERAL NO. 1 MINE  
FEDERAL MINING CORPORATION  
ELKHORN CITY, PIKE COUNTY, KENTUCKY

April 17, 1963

J. L. Gilley  
Mining Health and Safety Engineer

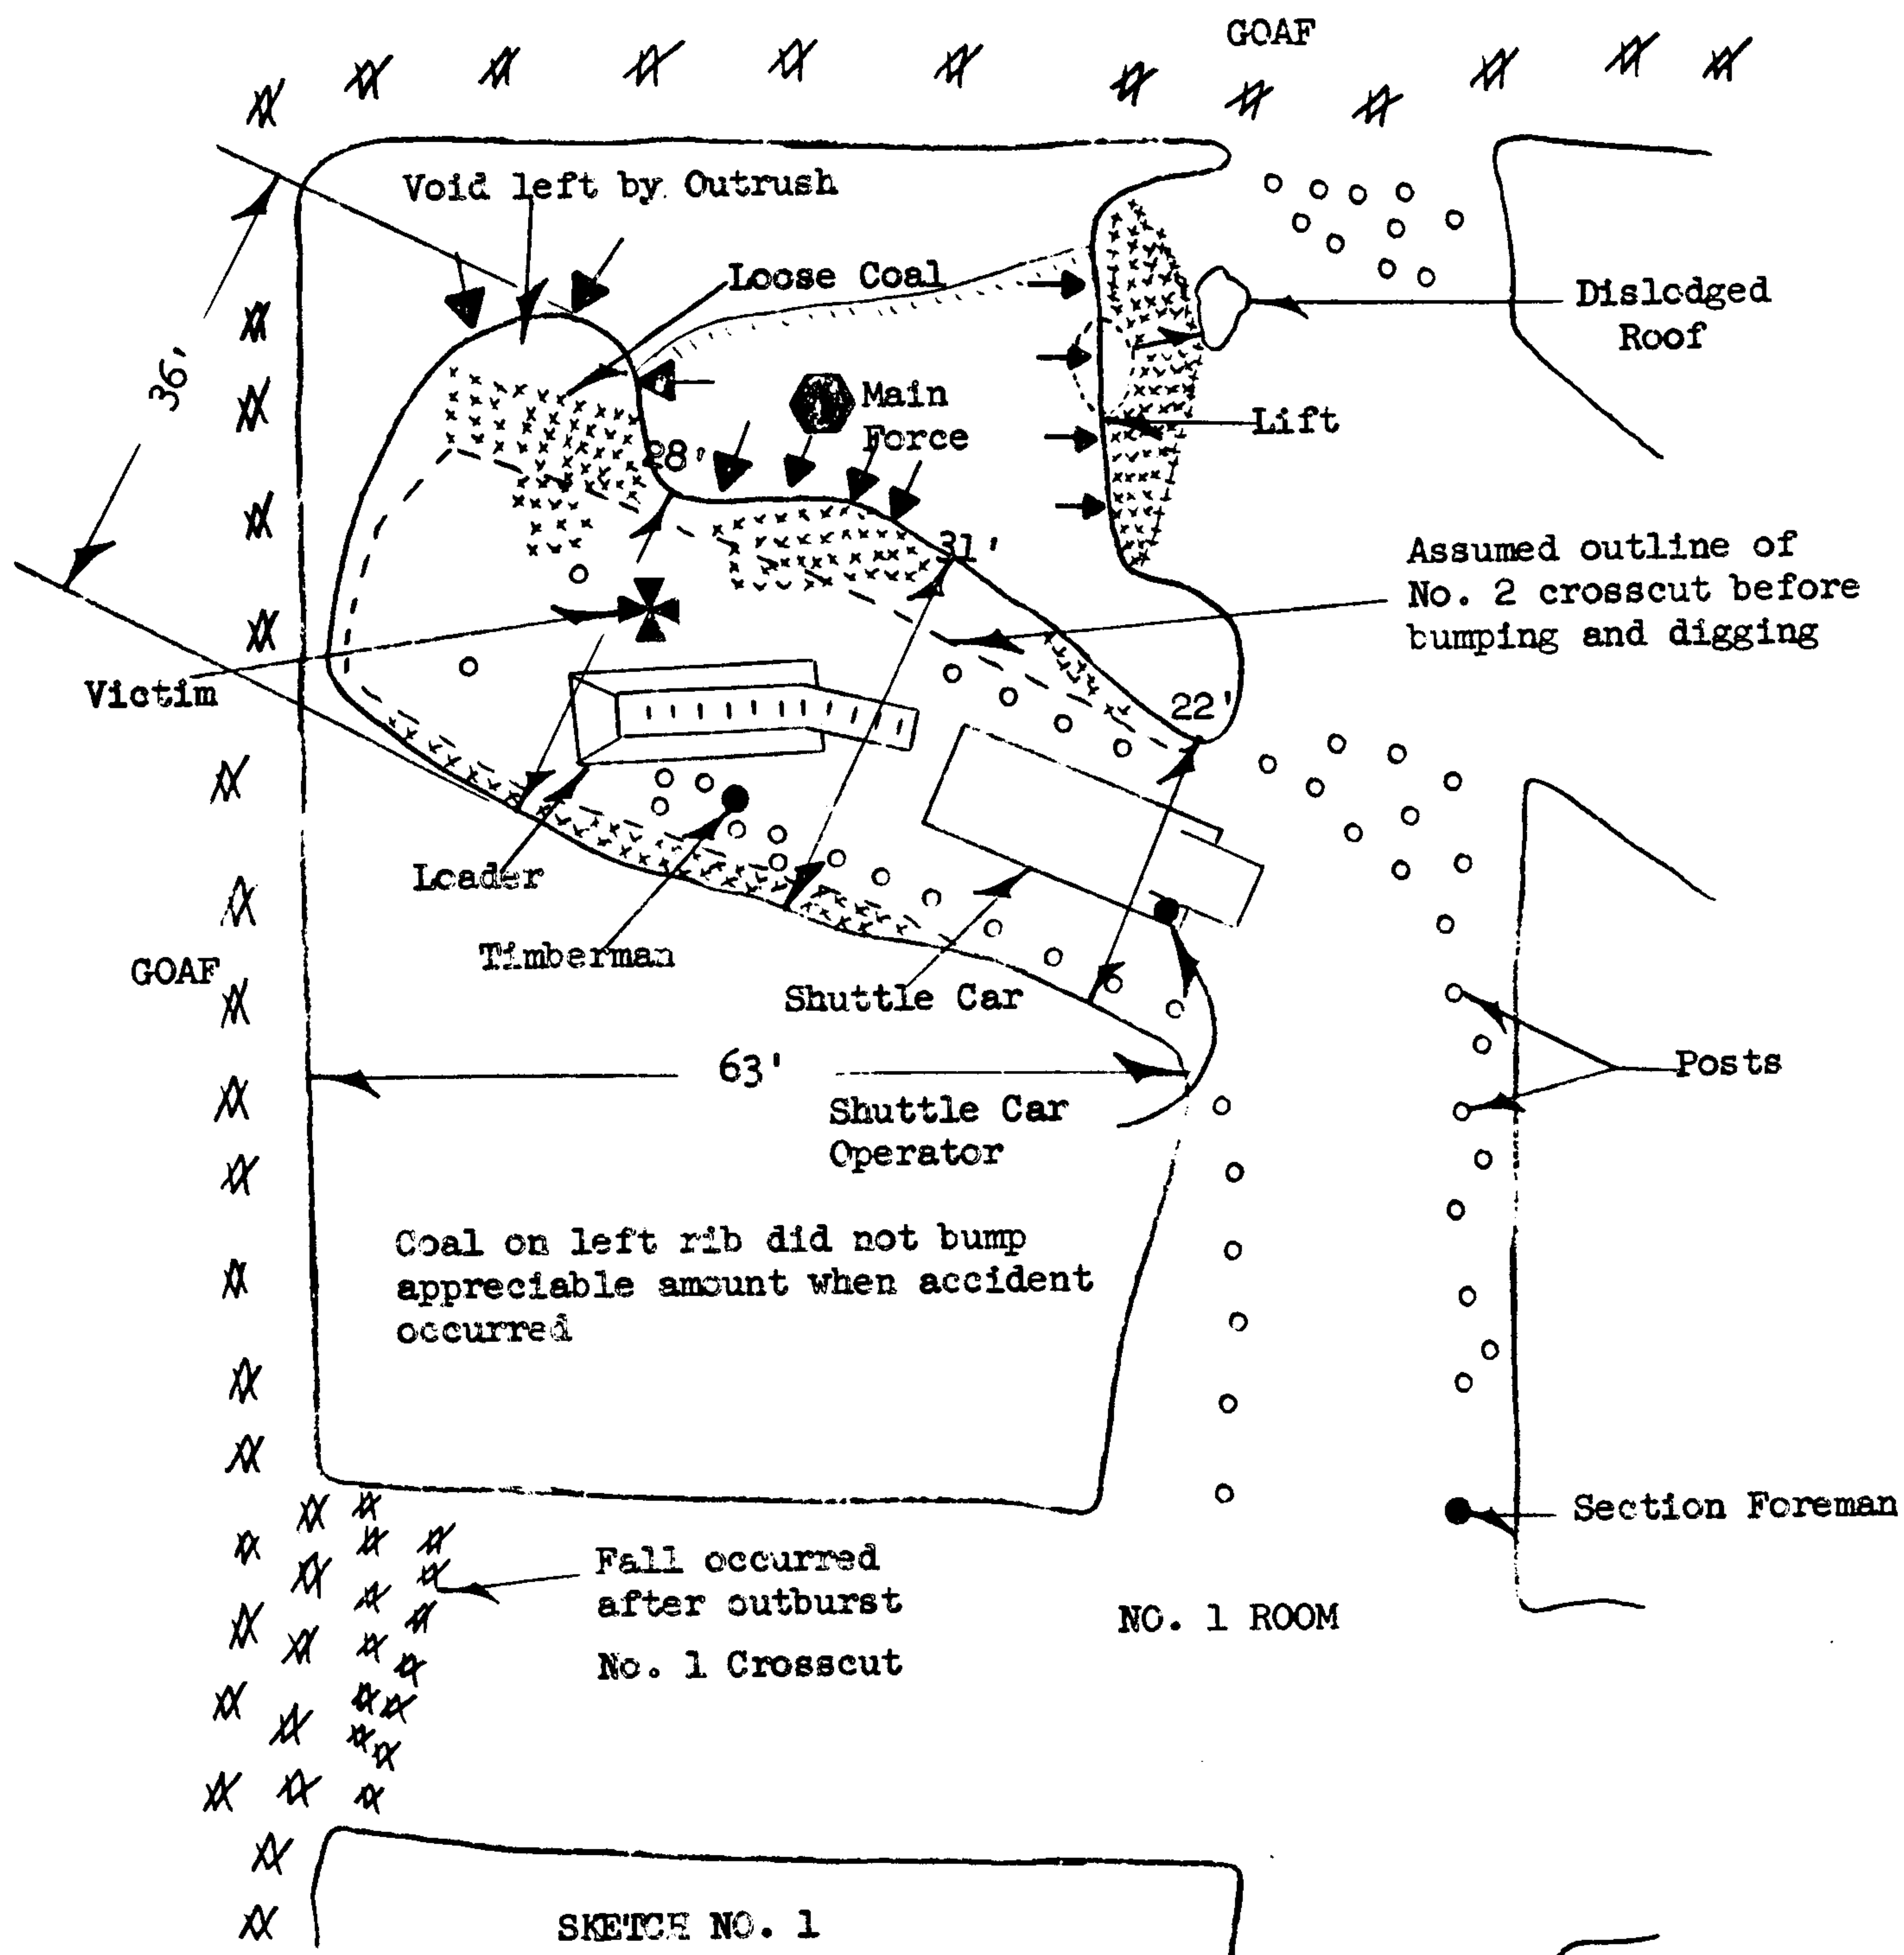
The mining system used, the extent of development and extraction, and the comparative dimensions of the coal pillars in the 4 east territory at the time of the coal bump are illustrated in sketches 2 and 3. The location of the workmen and equipment at the time of the bump and the extent of the area affected are shown in sketch 2.

The section foreman stated that while the second cut of coal was being loaded, a bump occurred in the No. 2 crosscut. (See sketch 1). Upon investigation, the foreman found that about 4 tons of coal had bumped from the right rib. He further stated that inasmuch as he had detected some broken roof along the roadway outby the first pillar lift, he decided to timber the pillar lift and start extraction of the pillar from the crosscut side where the bump had occurred. The loading machine was moved into the crosscut and the expelled coal from the pillar was loaded. The loading of coal from the face of the crosscut and pillar ribs was continued until the coal was too hard to dig with the loading machine. The loading machine was then trammed into the No. 2 room. The foreman had several timbers set in the new pillar place in the crosscut of No. 1 room, but did not have time to complete the timbering job before quitting time at 3 p.m.

On the evening of the coal outburst, the 4 east section night-shift crew, comprising 8 men and the section foreman, arrived on the section about 3:30 p.m. After the scrap cut in the No. 2 room and a cut of coal in the No. 3 room were cleaned up, the loading machine was then trammed into the "pillar pocket" started by the day-shift crew in the No. 2 crosscut of No. 1 room. The night-shift section foreman stated that when he examined the places on the section immediately prior to starting his crew to work, he discovered what he thought "was a cut of coal shot down by the day shift in the No. 2 crosscut pillar place", notwithstanding that the report from the day shift foreman indicated that the timbering job had to be completed in the place before it was ready for undercutting. A coal outburst had occurred in the place during the 30-minute interval between shifts and the foreman had mistaken the coal expelled by a bump from the ribs of the pillars for a cut of coal. The loading machine operator started loading coal in the No. 2 crosscut "pillar pocket" at about 5:00 p.m. The accident occurred at 6:45 p.m. Coal was being loaded into a shuttle car from the rib of the pillar on the right side of the crosscut, according to a timberman, who witnessed the outburst and who was setting timbers on the left side of the place about 10 feet from the loading machine, when the outburst occurred.

A void was left by the outburst of coal from the crosscut. The void measured from 6 to 24 inches in height, about 8 feet in width and extended about 16 feet in length. Expulsion of coal from pillar ribs was confined principally to the crosscut area in No. 1 room. Some coal was shaken from 2 or more sides of 4 other pillars. The roof was not affected insofar as could be determined, except at one place in an abandoned pillar lift. Four timbers were dislodged in the immediate area, and a few timbers were broken along the No. 1 roadway. The loading machine contactors were damaged and other parts of the machine were also damaged to some extent.

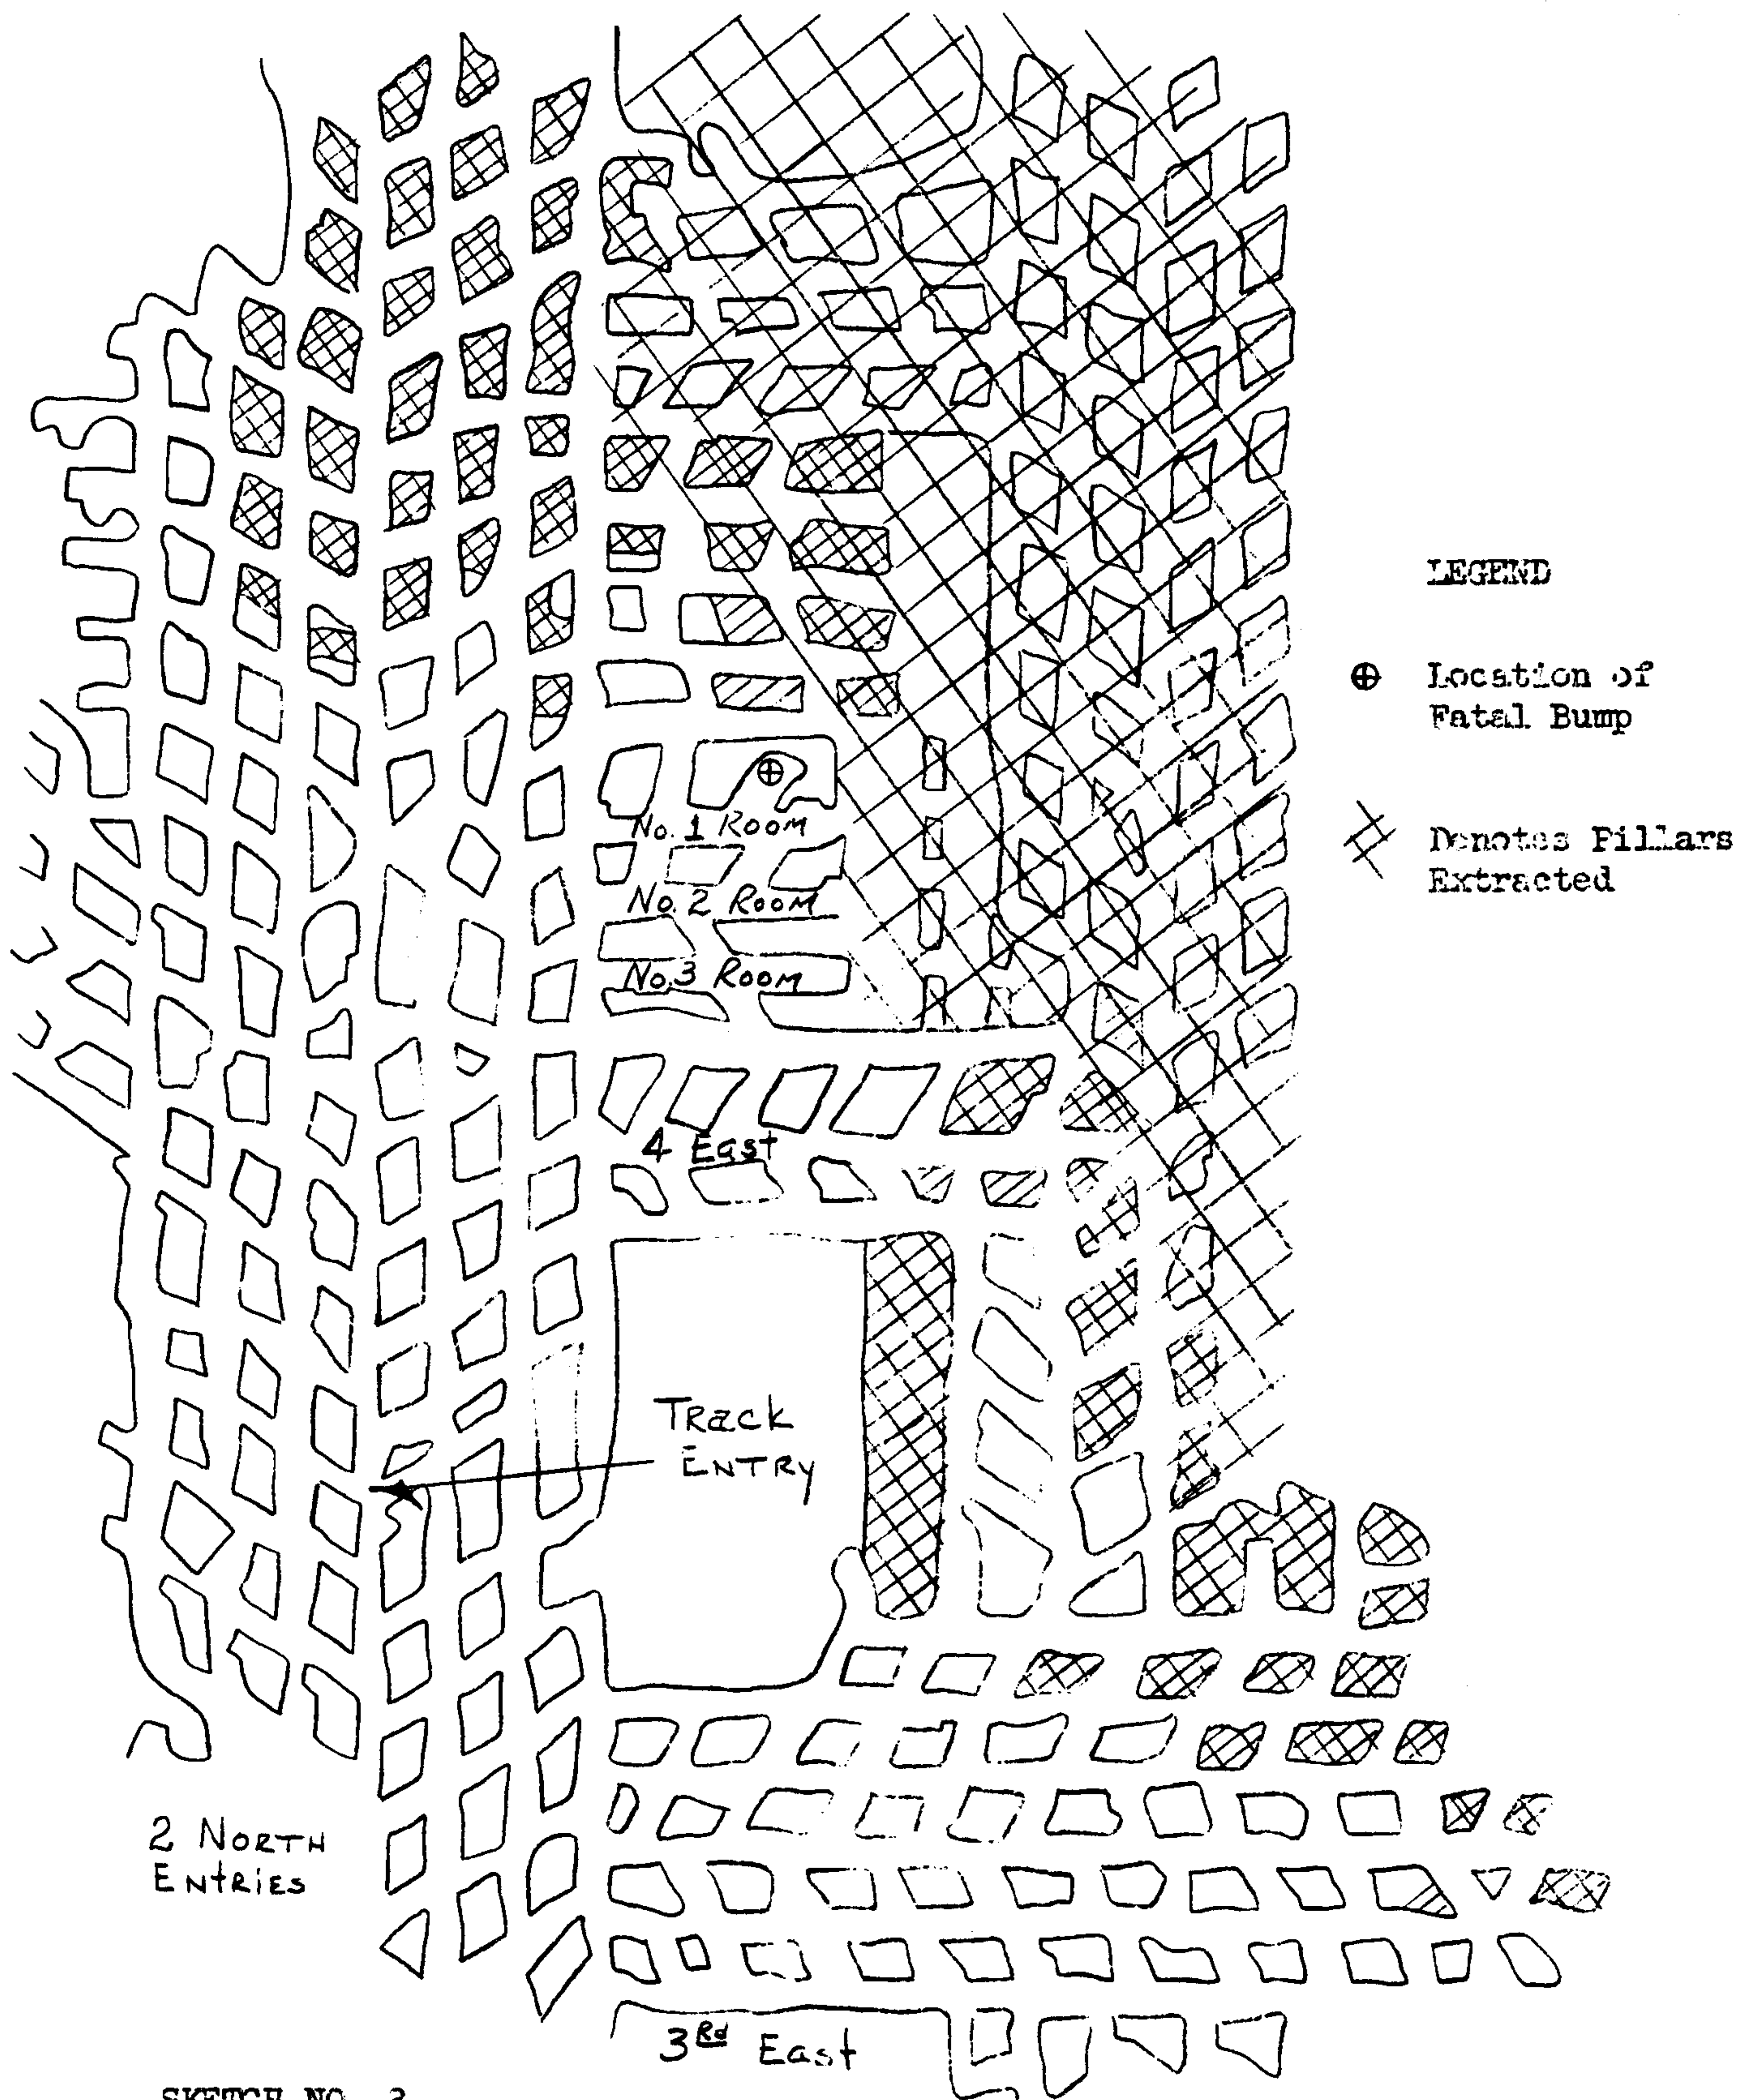
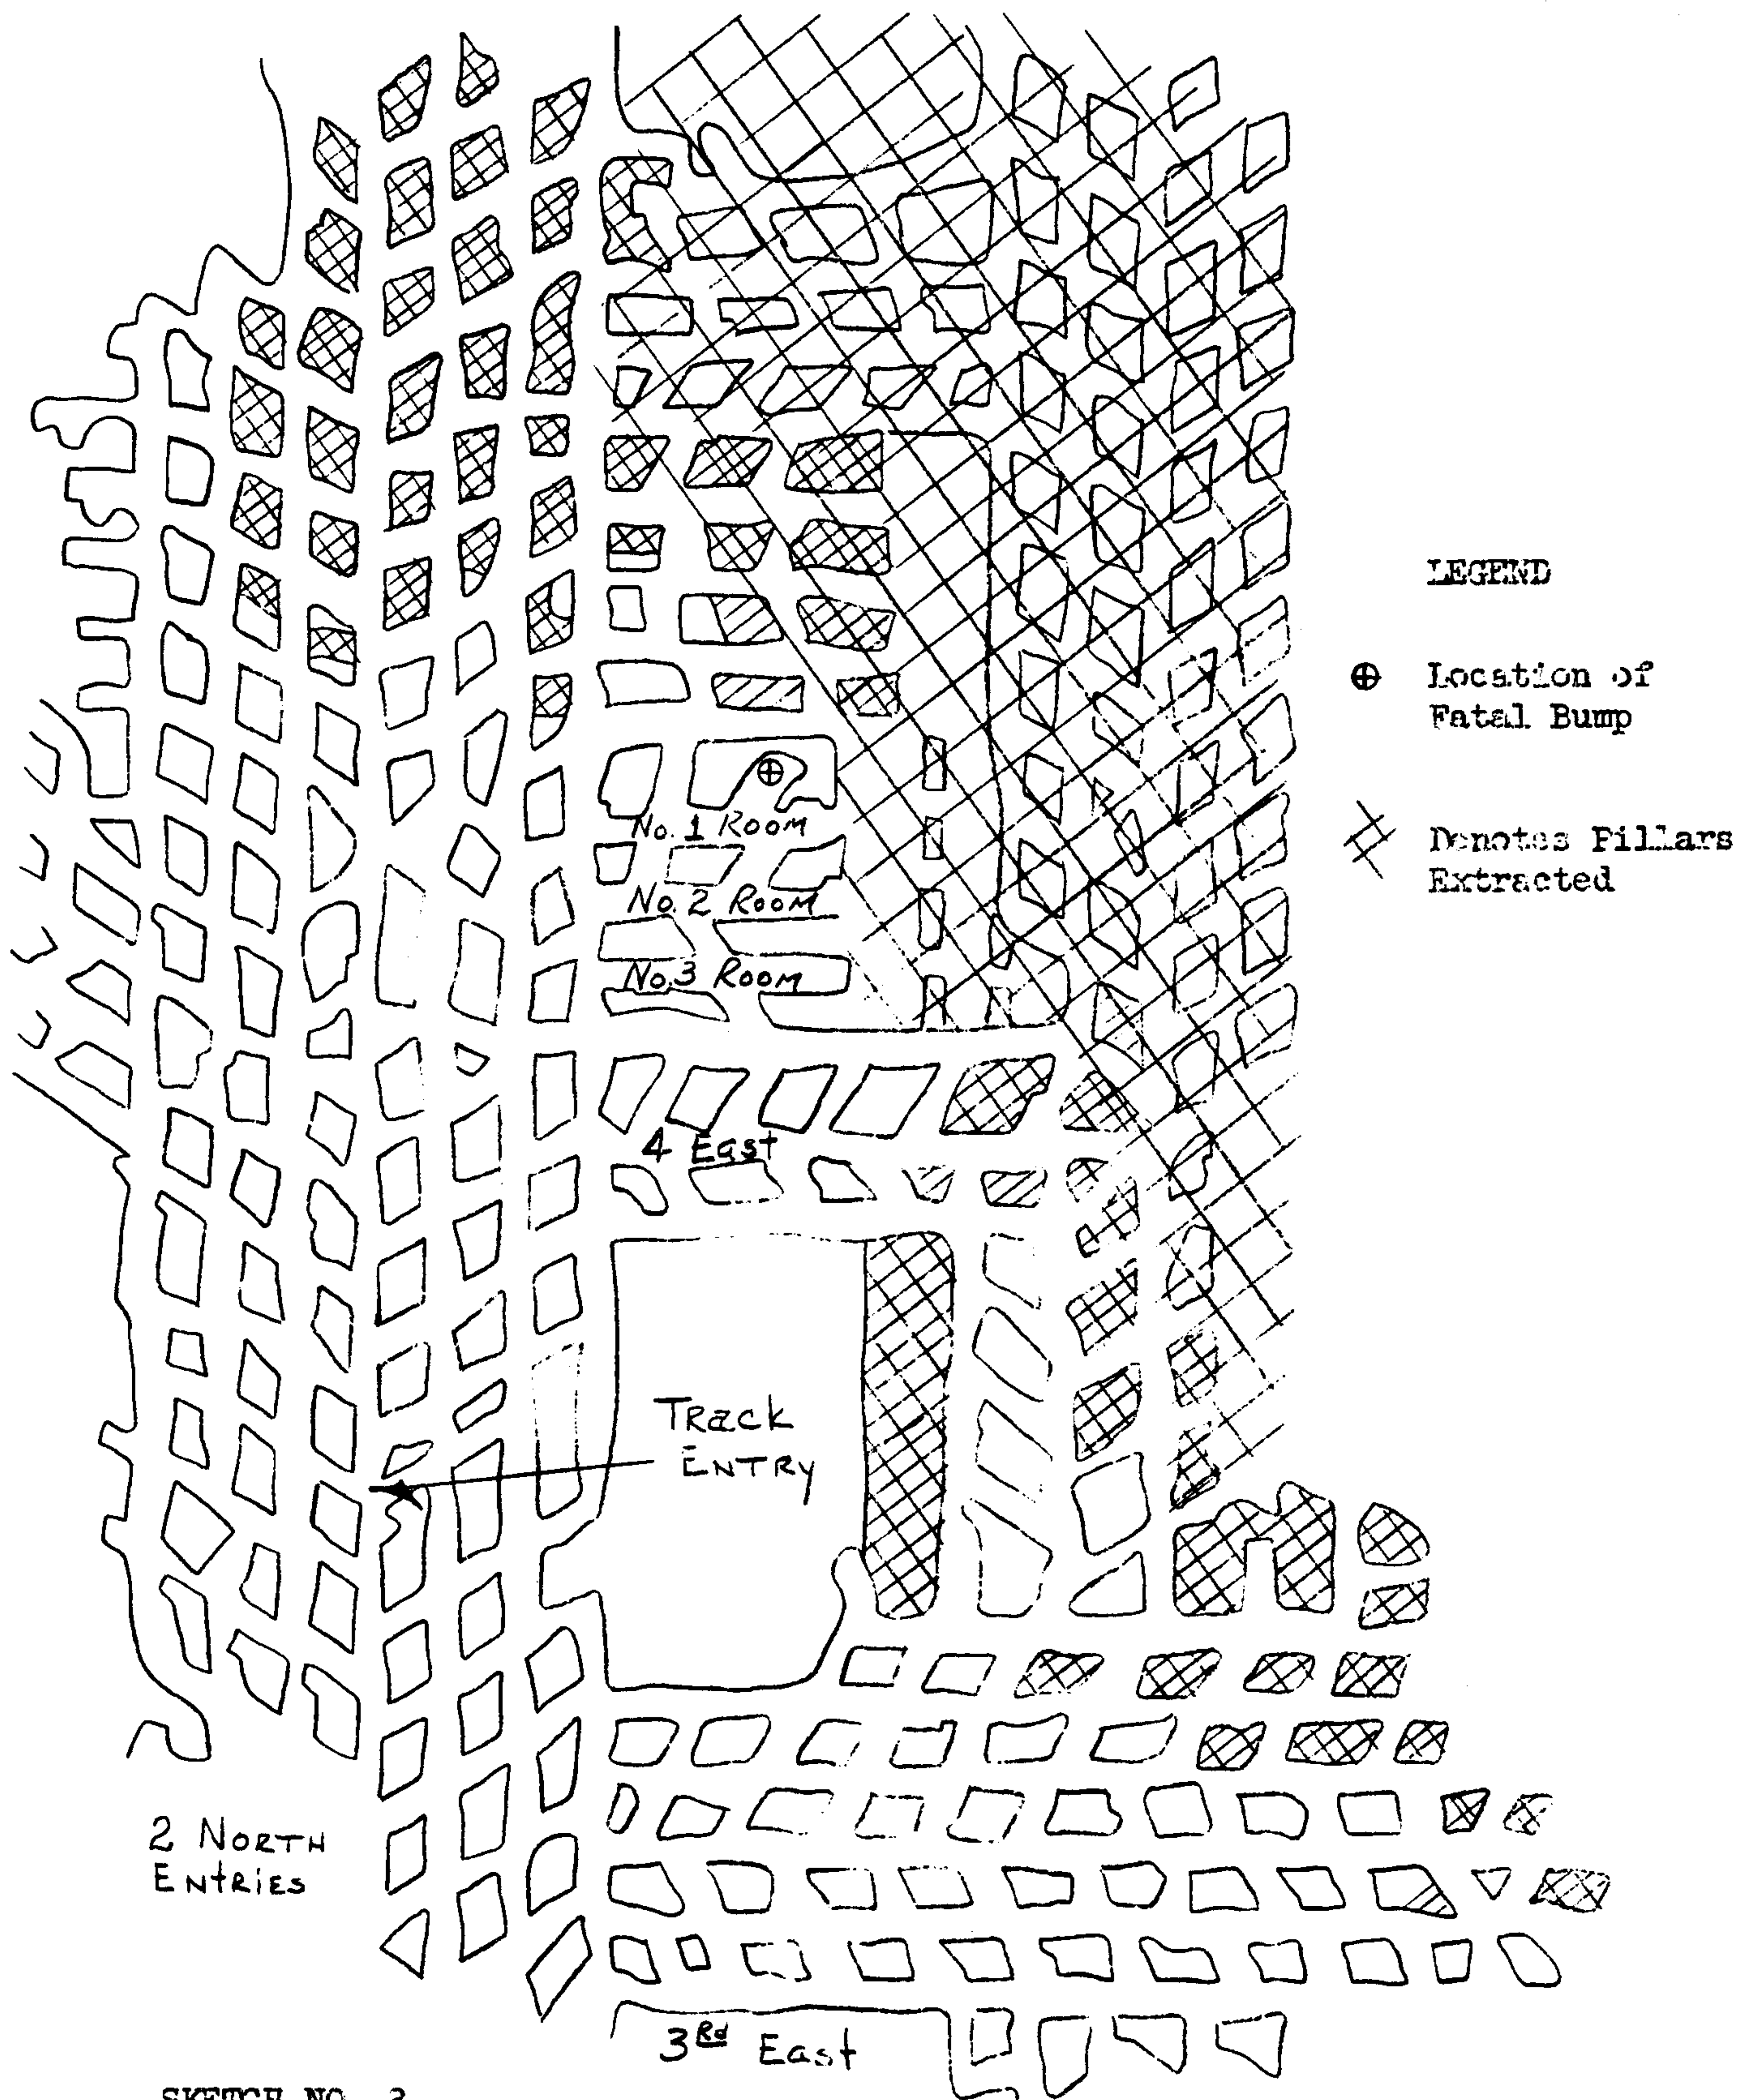
SKETCH NO. 3

Mining at the time of the outburst consisted of the extraction of entry and barrier pillars in 2 sections. In 1956, the 2 North entries were turned off the main entries and were driven 350 feet where a parallel set of multiple entries was projected. The 2 North group consisted of 7 entries driven 3,800 feet in depth, and the right group of 5 and 6 entries, extended to a depth of 4,400 feet. The 2 groups of entries were separated by 5 barrier pillars, ranging from 300 to 350 feet in width and from 400 to 500 feet in length. (See sketch 3.) After the 2 North entries were developed, pillar extraction was started in the

right group and the entry pillars were recovered for a distance of 3,000 feet, leaving the barrier pillars and the entry chain pillars on the left side intact. In 1960, extraction of the 2 North entry and barrier pillars was started and continued for a distance of 2,000 feet to the No. 3 barrier pillar involved in the outburst. This barrier was originally 320 feet wide and 490 feet in length, but it had been reduced to 200 feet in width and 220 feet in length when 3 rooms designated as Nos. 1, 2 and 3 were projected for development preparatory to extraction. At the time of the outburst, the 3 rooms were being driven simultaneously, nearly abreast, through the barrier pillar directly toward the old gob area completed in 1962. It was reported several pillar remnants of various dimensions were not mined in the area. From sketch 2, it will be noted that more coal was left for pillaring from No. 1 room than the other 2 rooms. The widths of the rooms varied from 21 to 31 feet and the crosscuts were driven at irregular intervals. This unsystematic method of projection and development of the barrier pillar resulted in the formation of pillars of various dimensions and shapes. From sketch 2, it will be noted that the pillars in No. 1 room were not only the largest of the group, but were situated adjacent to a previously mined-out area that formerly comprised the inby portion of the contingent barrier pillar and formed a pillar-line point.
